### **GENERAL ORDINANCE NO. 17, 2016**

AN ORDINANCE AMENDING CHAPTER 8, TRAFFIC AND PARKING REGULATIONS, OF THE *TERRE HAUTE CITY CODE*.

Traffic Study – 25<sup>th</sup> Street and Wallace Avenue.

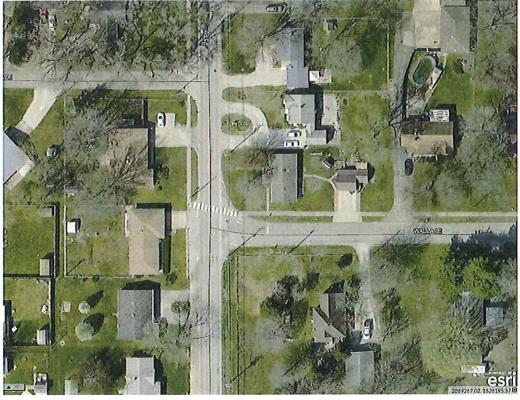
Figure 1.

A traffic study was conducted at the intersection of S. 25<sup>th</sup> Street and Wallace Avenue (See Figure 1) due to safety concerns at the intersection including speeding, traffic not stopping, and danger to pedestrians (school children). The traffic study consisted of observation of the intersection and the use of traffic counting devices on both 25<sup>th</sup> St. and Wallace Ave. Additionally, speed data was collected on 25<sup>th</sup> Street. Traffic data is shown in Figures 2 and 3.
